# Manhole Inspection Summary

Manhole # S41C\_\_017MH

Insp Date: **6/27/08 2:00 PM**

**Location** Address: **301 n central ave**

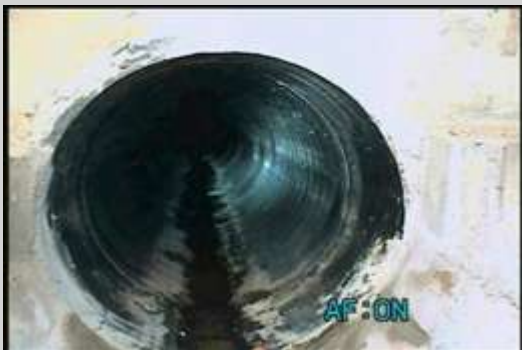
12 O'Clock Outflow

Comments **Pipe at 12 may be steel**

8 in. Circular Gravity Sewer  
Pipe Out @ 12 O'Clock

Pipe Material: **Unknown** ☐ Pipe Lined

Invert Depth: **3.76** (ft.) Flow Characteristics: **None**

Infiltration: **None** Pipe Seal Cond: **Unknown**

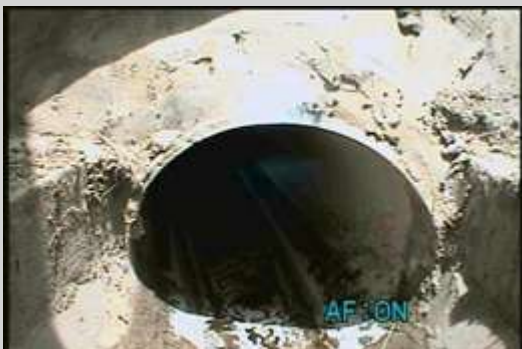
6 O'Clock Inflow

8 in. Circular Gravity Sewer  
Pipe In @ 6 O'Clock

Pipe Material: **PVC** ☐ Pipe Lined

Invert Depth: **3.66** (ft.) Flow Characteristics: **None**

Infiltration: **None** Pipe Seal Cond: **Unknown**
